MITIGATION OF COLLAPSE RISK IN VULNERABLE CONCRETE BUILDINGS

Lisa Matchulat

Structural Engineering and Engineering Materials
SM Report No. 93
January 2009

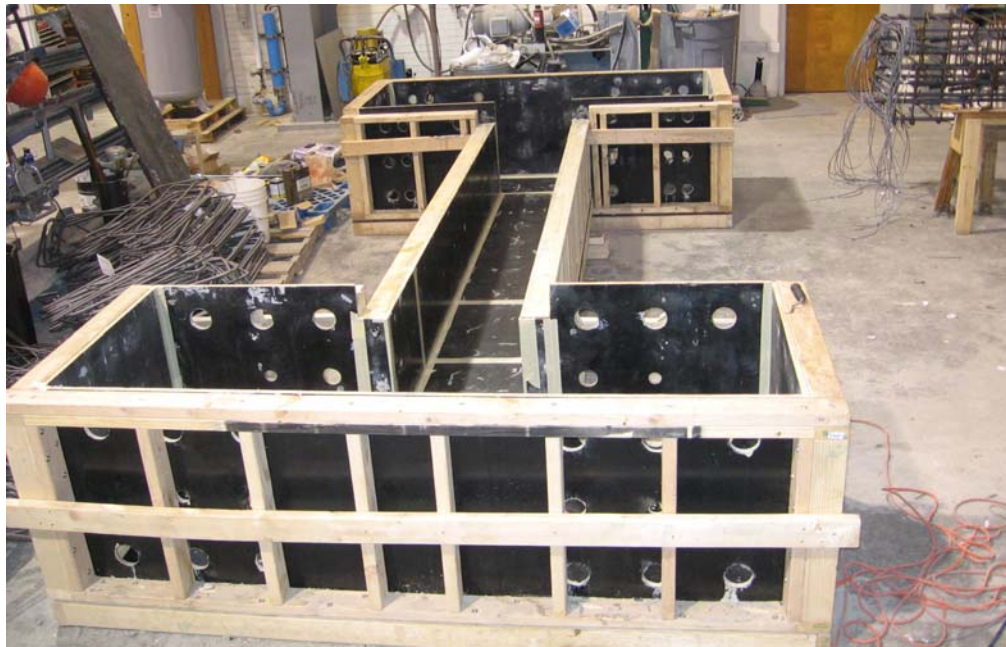
Figure 2.15: Specimen formwork

The specimens were cast in the horizontal position, using a single batch of five cubic yards of concrete per specimen. The concrete was placed in two lifts, with samples taken for strength specimens between the two lifts. The concrete was consolidated by internal vibration to minimize the presence of voids, as shown in Figure 2.18. Following placement and vibration of the second lift, the top surface of the specimen was struck off and finished using hand trowels. Figure 2.19 shows a photograph of a specimen immediately following finishing procedures. Afterward, the specimen was covered with wet burlap and plastic sheeting. Wood formwork was stripped after four days of moist curing and the specimens were air-dried as they were stored inside the Structural Testing Laboratory until they were ready to be transported to the MAST Laboratory.

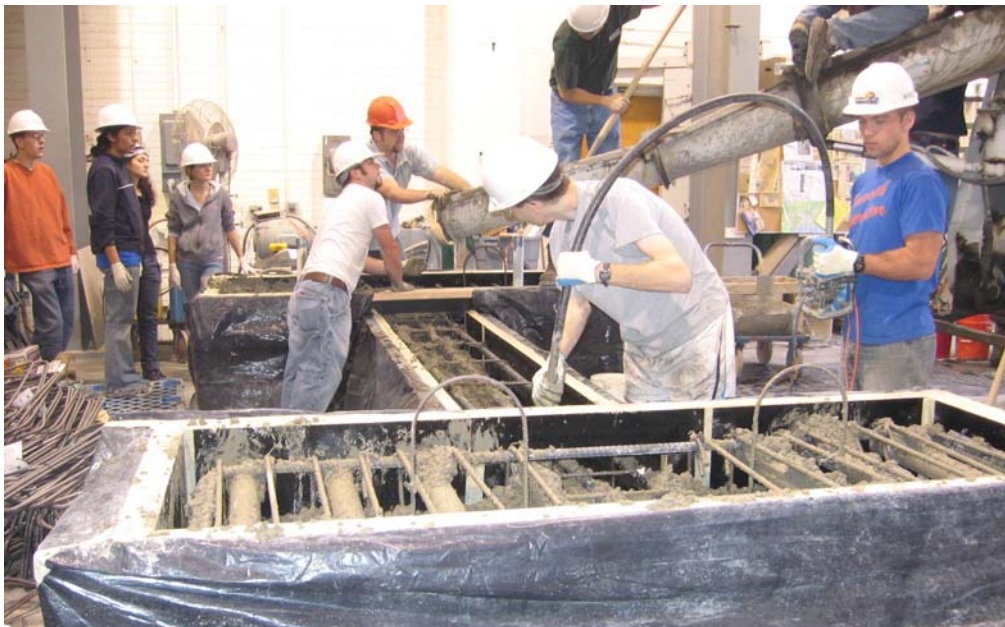
Figure 2.18: Internal vibration during concrete placement

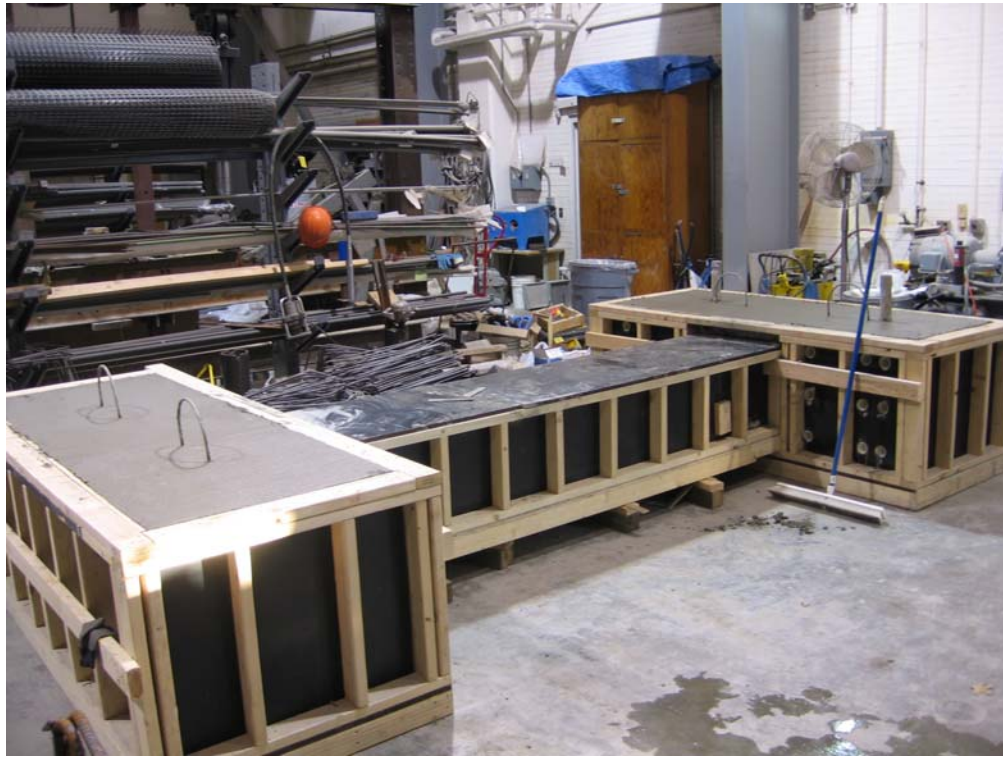
Figure 2.19: Finished column test specimen

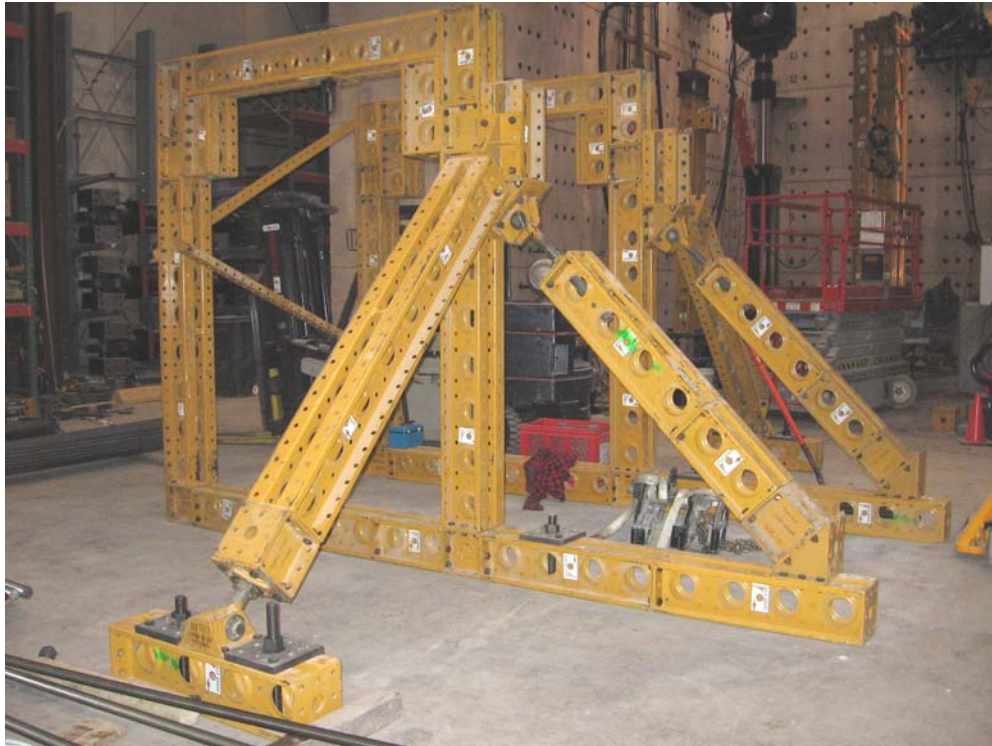
Figure 2.20: Tilt-up frame used to rotate specimens into the vertical position

Testing was performed at the MAST (Multi-Axial Subassembly Testing) Laboratory at the University of Minnesota. Following construction and curing, the specimens and base block were shipped to the laboratory on a flatbed truck and unloaded by the laboratory staff. After arrival at the MAST Laboratory, the specimens were tilted up into the vertical position using the frame shown in Figure 2.20. The base block and specimens were then moved from the staging area of the laboratory to the reaction floor using the crane. Final positioning was performed using the crosshead of the multi-axial loading system.

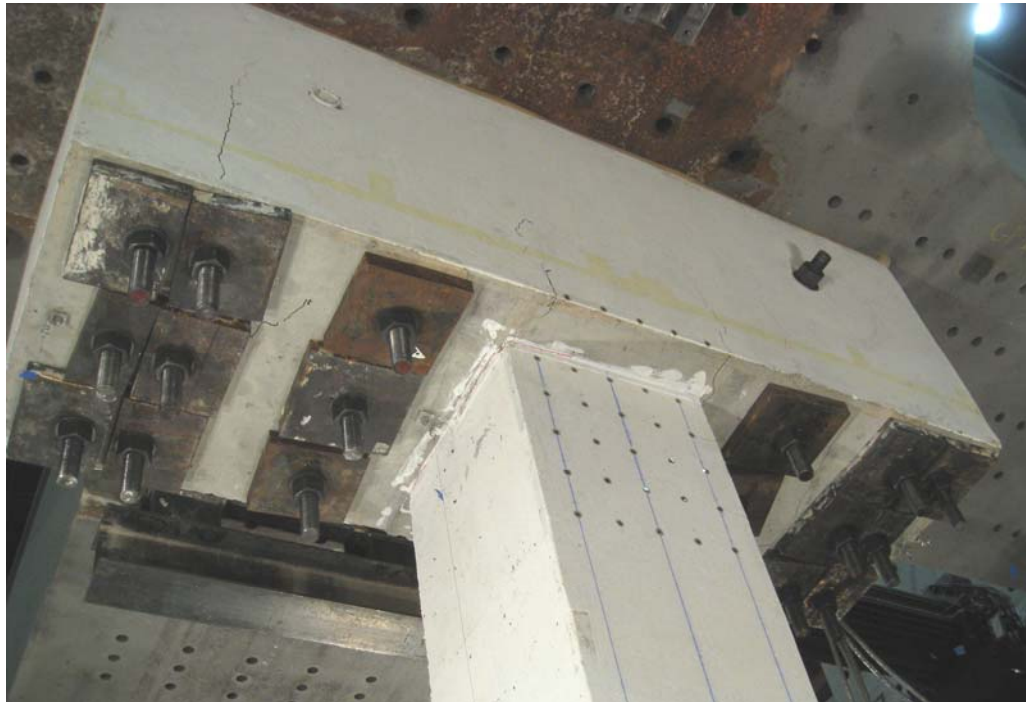
Figure 2.21: Top beam connection to the crosshead

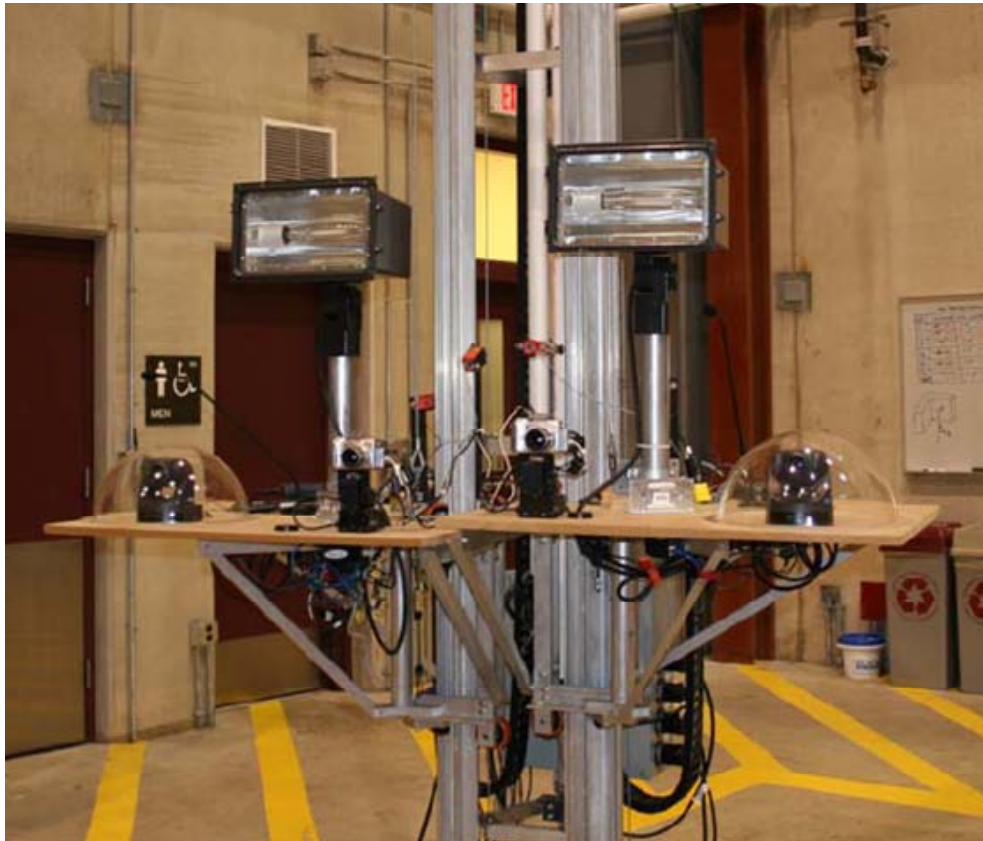
Figure 2.29: Telepresence camera tower

Four camera towers were used to obtain a photographic record of each test. Each tower had two shelves, each with one still and one video camera, as shown in Figure 2.29. The layout of the camera towers is shown in Figure 2.30. A set of photographs was taken with all cameras at the peak lateral drift ratio for each cycle. Two additional data collection methods were used to achieve a greater degree of detail and accuracy in the monitoring of deformations in the maximum moment regions of the columns.

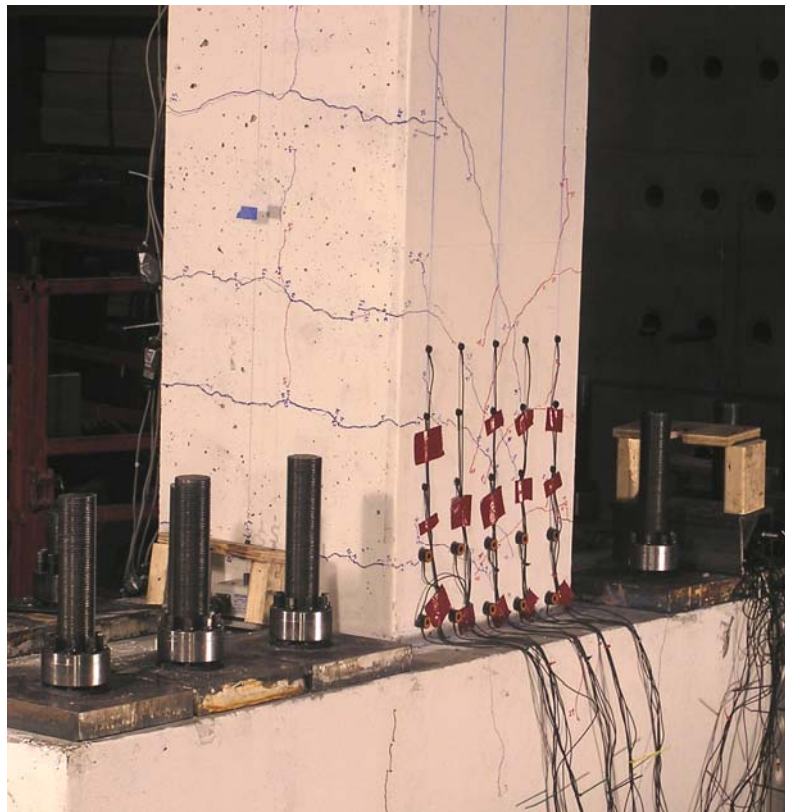
Figure 3.3: Specimen 1 crack pattern at a drift ratio of 0.75%

(a) Top column end, north face, (b) Bottom column end, northeast corner

During the cycles to a drift ratio of 0.75%, there was significant growth in the inclined cracks on the north and south faces of the column, with cracks from opposite sides of the column crossing near the center of the north and south faces, as shown in Figure 3.3. Additional horizontal cracks formed on the east and west faces, along with several vertical cracks, indicating splitting of the concrete cover along the

longitudinal reinforcement. No cracking was observed in the middle third of the column at this displacement level.

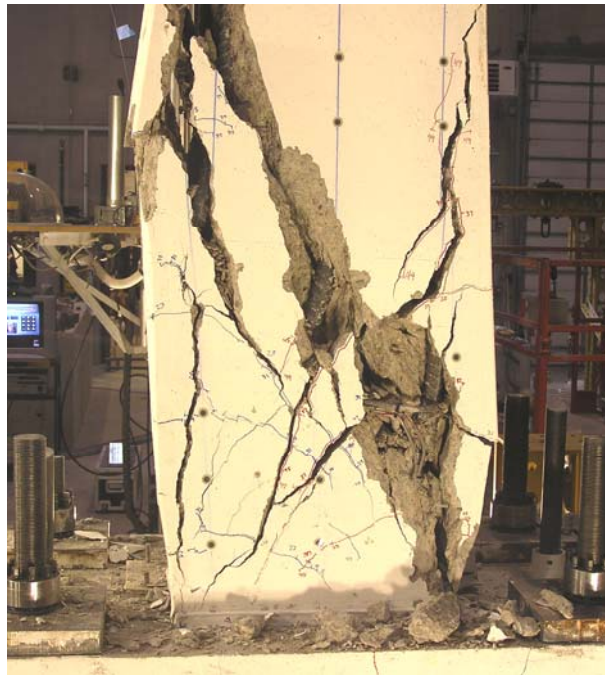
Figure 3.4: Specimen 1 crack pattern at a drift ratio of 1.00% (after axial failure)

(a) Bottom column end, south face, (b) Bottom column end, north face

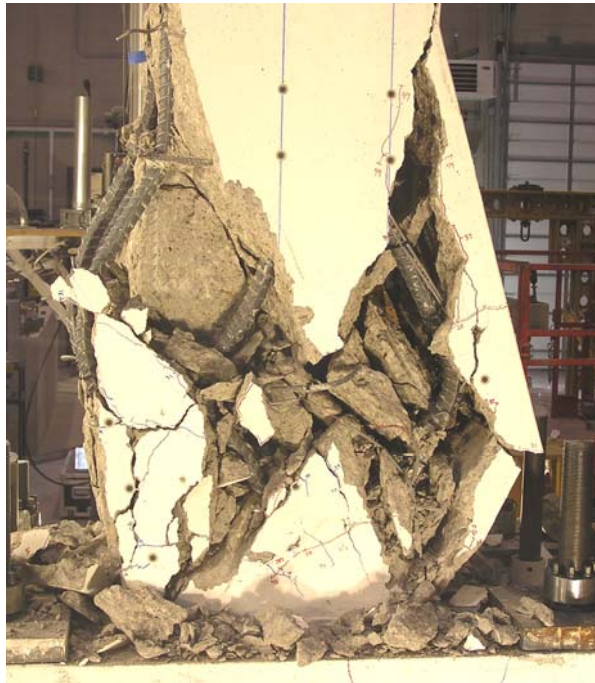
Figure 3.5: Specimen 1 condition at the end of the test

(a) Bottom column end, south face, (b) Bottom column end, north face

allowed the longitudinal bars on the west side to buckle outward as well. Anchorage failure was not observed in Hoop 5, which was able to restrain longitudinal bars on all sides. This resulted in a mushroom-shaped deformation pattern of the longitudinal bars.

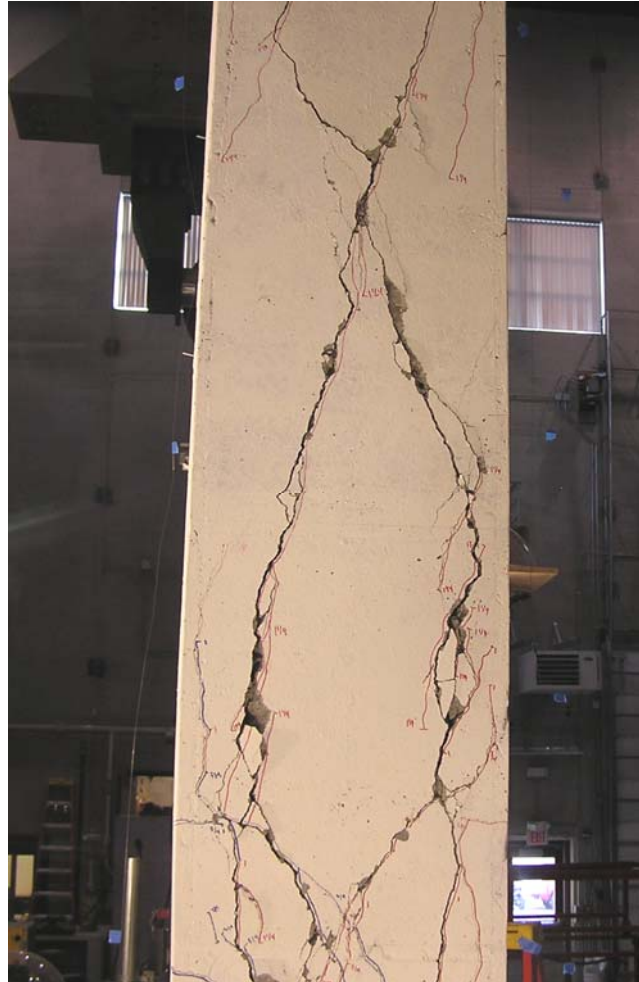
Figure 3.10: Specimen 2 crack pattern at a drift ratio of 1.25% (after axial failure)

(a) Center of column, north face

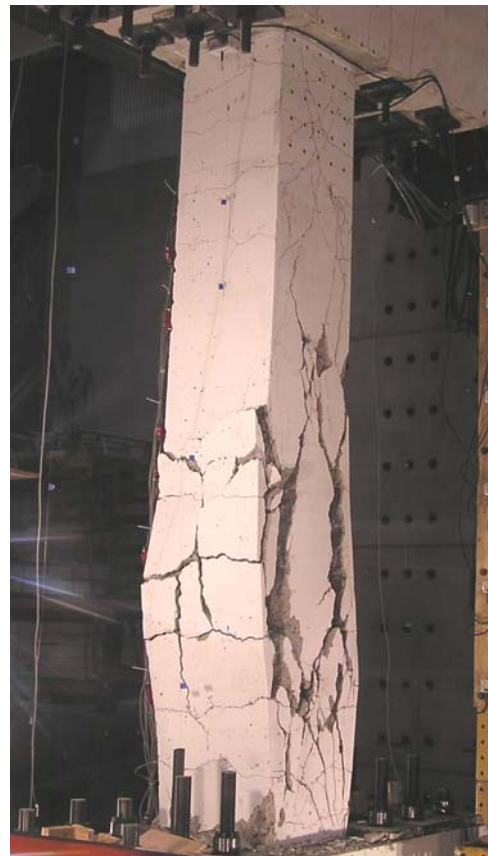
Figure 3.11: Specimen 2 condition at the end of the test

(a) Bottom column end, south face, (b) Full column, northeast corner

The condition of the column at the completion of the test is shown in Figure 3.11. At the end of testing, Hoop 6 was still intact, while Hoop 5 had opened at the southeast corner, indicating an anchorage failure. The longitudinal bars on the west face of the column deformed between Hoops 5 and 6. On the east side of the column, the far northeast bar bent outward between Hoops 4 and 5, while the other two bars on the east side deformed outward between Hoop 4 and Hoop 6, as Hoop 5 had opened up. This resulted in an S-shaped deformation pattern of the longitudinal bars.
